Rapid Communication

## A Preliminary Investigation into the Morphology of Trabecular Bone Damage Associated with Intervertebral Disc Herniation

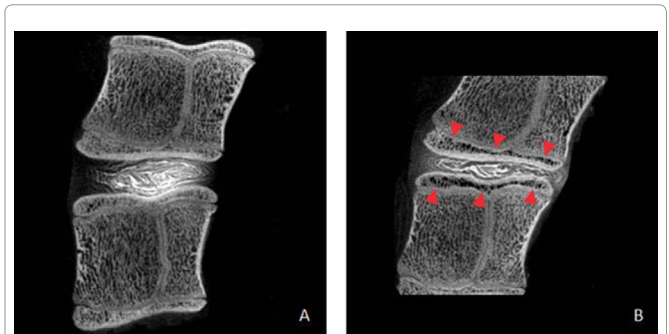
**Figure 1:** (A) Porcine spine specimen prior to mechanical testing. (B) Same specimen after undergoing a herniation protocol, note the distinct regions directly beneath the endplate where the trabecular bone appears to have fractured and the density reduced. Arrowheads denote the boundaries of trabecular bone damage.

Evidence of intervertebral disc herniation was present in all specimens that were mechanically tested. No disc herniations were identified in any control specimens. Micro CT images of the test specimens were reviewed in high contrast to accentuate trabecular detail. Review of the images from the tested specimens revealed sub-cortical lucent regions (Figure 1) consistent with gas density and evidence of decreased trabecular density immediately deep to the vertebral endplates to a variable degree in all tested specimens. This phenomenon was not observed in control specimens that underwent

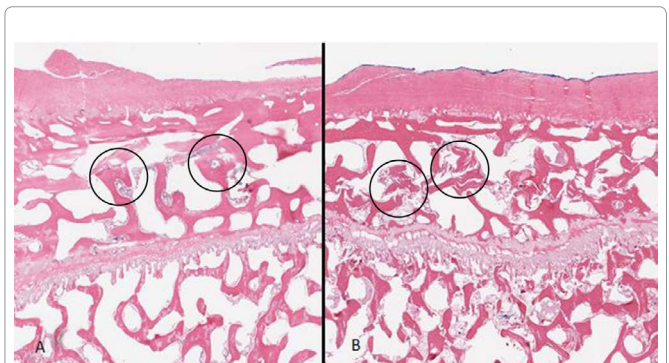
**Figure 2:** (A) Microscopic image slice of a control specimen in the area directly beneath the endplate. Normal regions are circled for comparison with abnormal regions in (b). (B) Microscopic image slice of a fatigued specimen where there is evidence of fracturing and buckling of the trabecular bone not seen in the control specimen. Selected abnormal buckled regions are circled in order to highlight the differences between the undamaged specimen in (a) and the damaged specimen here.

the mounting procedure but were not subject to mechanical testing. Tested specimens that underwent microscopy demonstrated sub-endplate trabecular fractures (Figure 2).
